WEST HILL POND DAM

CT. 00377

PHASE I INSPECTION REPORT
NATIONAL DAM INSPECTION PROGRAM

JANUARY 1979

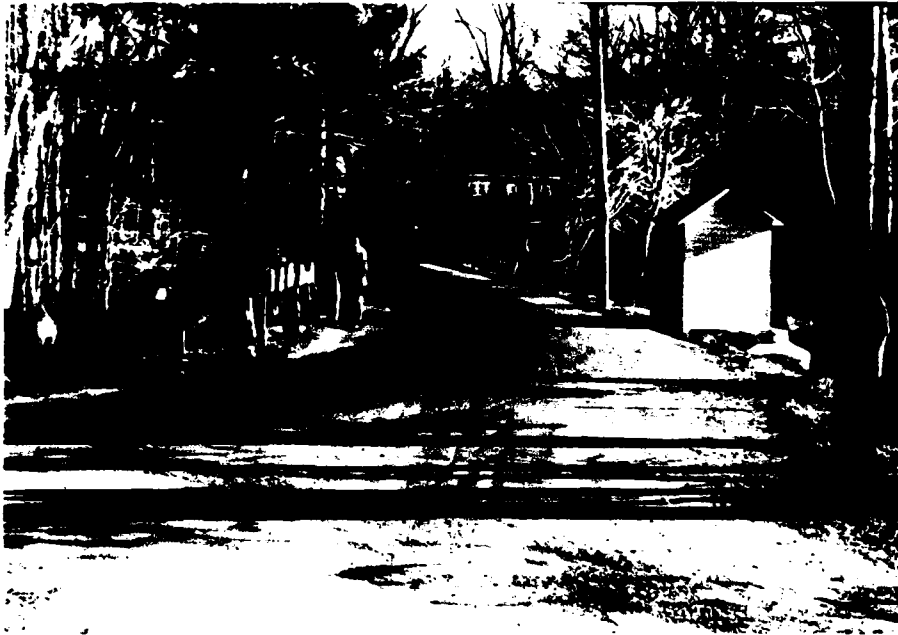
1. Road over dam and gatehouse from left abutment.
